Water Companies - Brede

November 2004

BoreSaver In Water Company Rehabilitation.

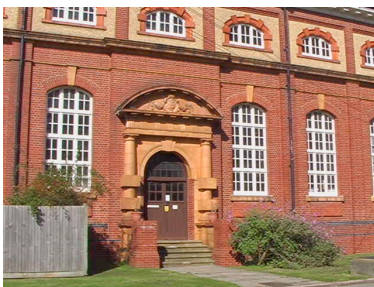
The Brede site in Hastings England is a complex system of tunnels, wells and adits. At over 100 years of age, the facility was in desperate need of rehabilitation due to the build up of iron oxide residues.

Extensive planning and consultation is required for important public supply facilities such as Brede. These facilities need careful analysis to enable safe and effective cleaning. BoreSaver Ultra C and BoreSaver Liquid are ideal for these projects with a proven history of success.

With such a massive system of wells and tunnels, clearance pumping was carried out for 5 days. In normal wells and bores, this can be accomplished in just a few hours.

We took pumped groundwater samples throughout the rehabilitation project. After 5 days of clearance pumping the raw water was returned to background values. A GCMS scan, taken after clearance pumping, did not show the presence of any residues from the use of BoreSaver Ultra C.

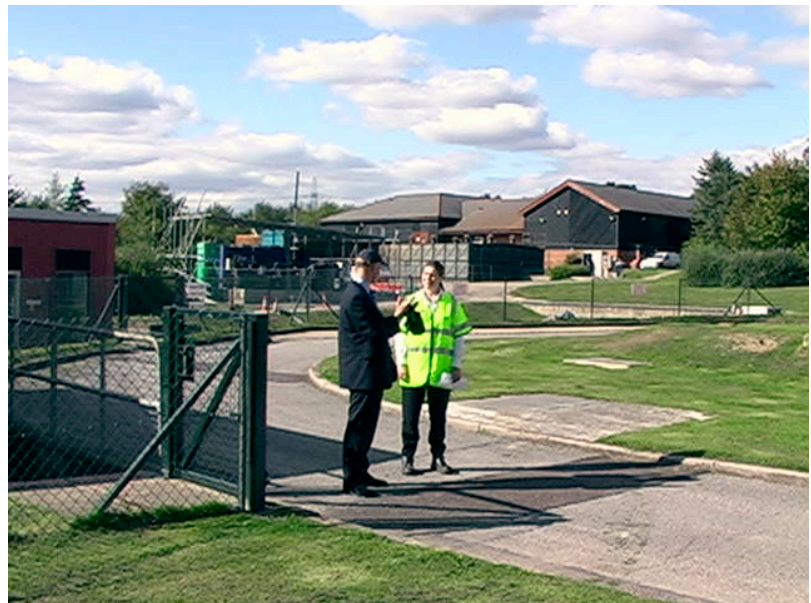
System Details

**Three Wells with a diameter of 3m and 80m in depth
Adits (tunnels) 400m & 20m long connecting the wells
Water volume in the system is approximately 1,726,000 L**
