# Mine-site Dewatering - QLD

## 467m Deep DeWatering Bores Treated With BoreSaver

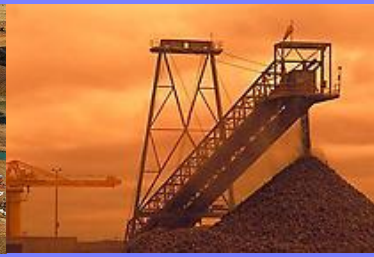
Two of the four main open cut mine de-watering bores were badly affected by iron oxide deposits. These deposits caused over heating in four very large expensive pumps which resulted in them seizing every 10 days.

BoreSaver Ultra C was mixed with water and then pumped through to the top of the pump. The iron dissolves back into solution allowing the residues to be safely pumped away to waste.
